# THE SECRETARY OF THE INTERIOR'S STANDARDS FOR REHABILITATION & ILLUSTRATED GUIDELINES ON SUSTAINABILITY FOR REHABILITATING HISTORIC BUILDINGS

Anne E. Grimmer with Jo Ellen Hensley | Liz Petrella | Audrey T. Tepper

U.S. Department of the Interior  
National Park Service  
Technical Preservation Services  
Washington, D.C.

2011

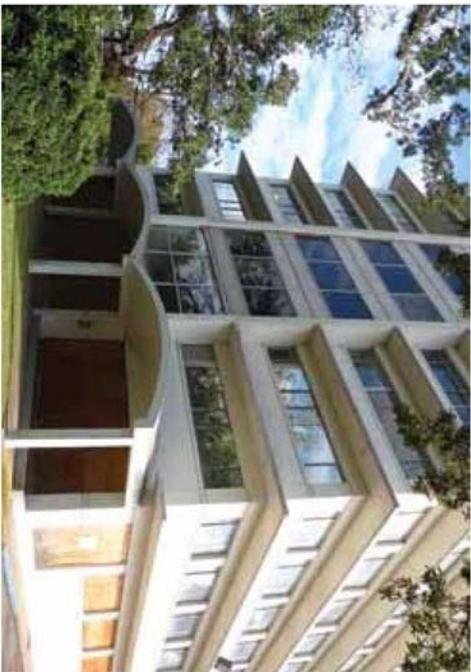
[4] Covered walkways and horizontal sun screens are distinctive and sustainable features in some mid-century modern office buildings.

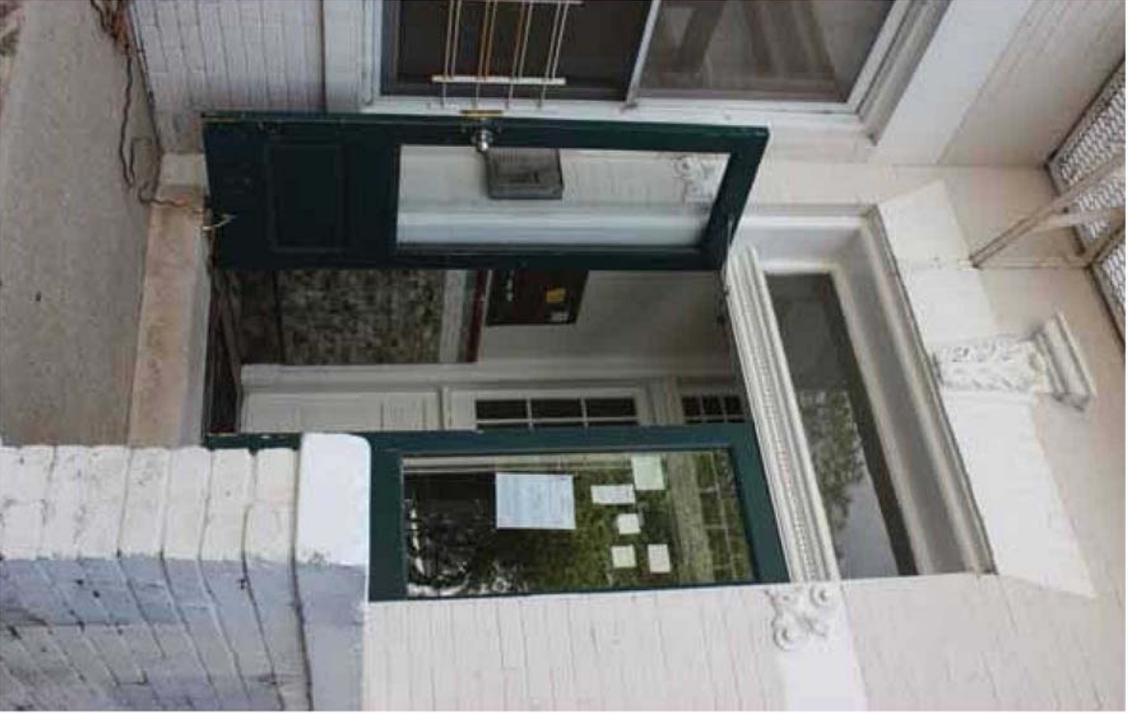
[11] A vestibule helps retain interior conditioned air in the living space in this historic row house.

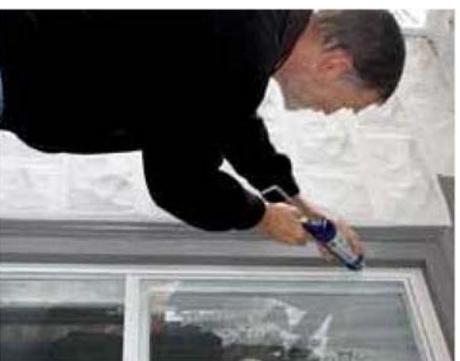
19

**Recommended:** [19] Caulking the gap between the aluminum storm window and wood window frame helps maximize thermal efficiency in this historic residence.

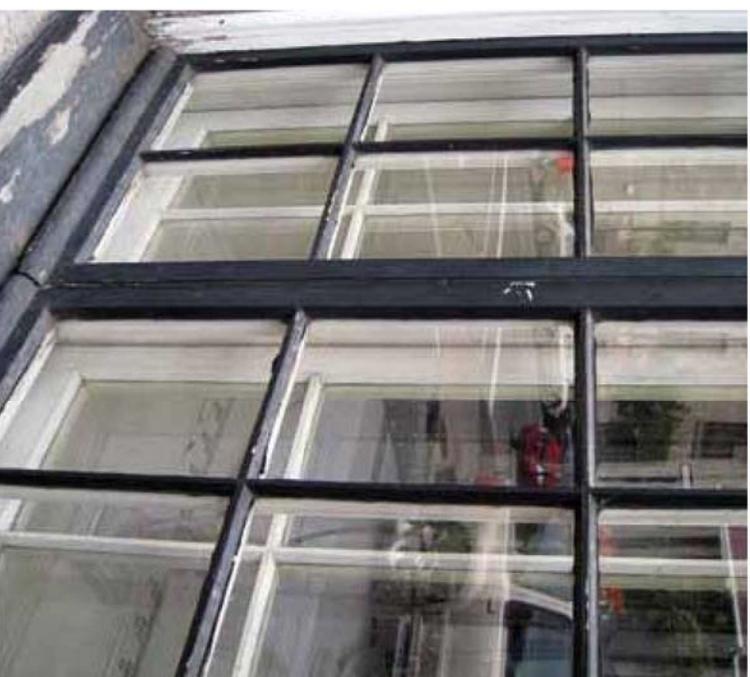
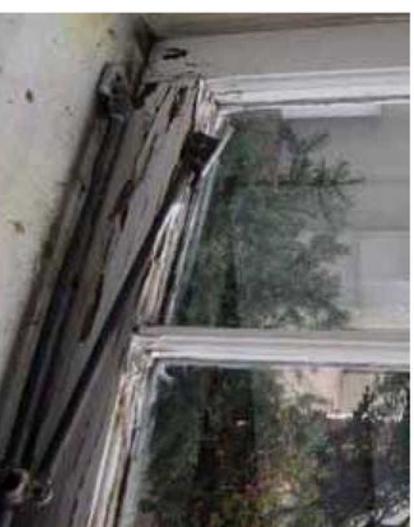
**Not Recommended:** [21-22] The peeling paint on an exterior window sill and on the interior of a window indicates that these features have not received regular maintenance. The broken casement window hardware also needs to be repaired to make the window operable.

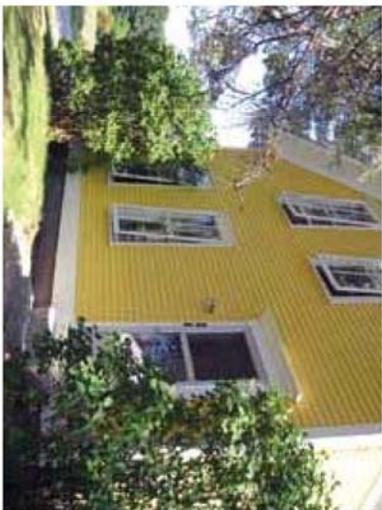
25

**Not Recommended:** [27] A broken sash cord can be repaired easily and does not justify replacement of the window.

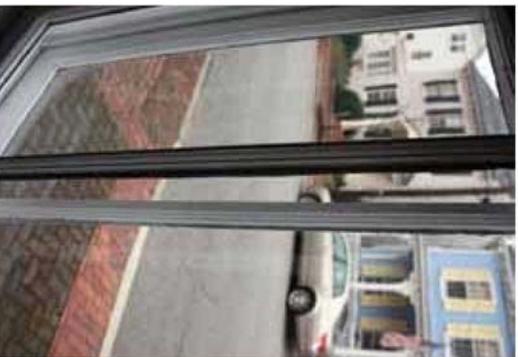
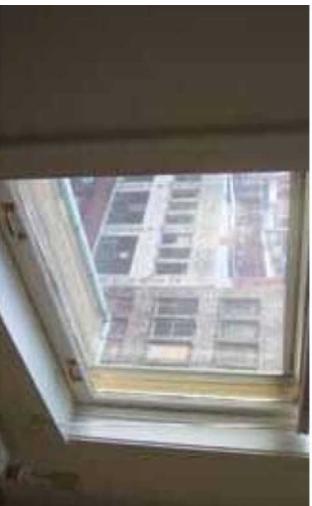
**Recommended:** [28-29]  
 These exterior storm windows match the pane configuration of the historic interior windows in a residence and in a multi-story hotel building.

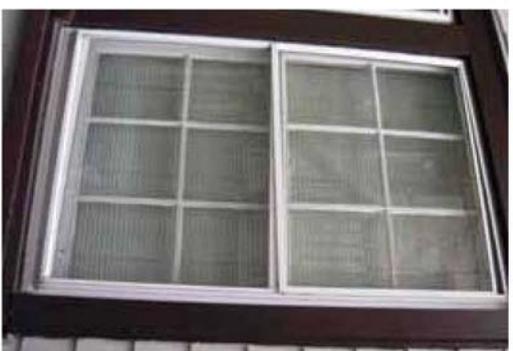
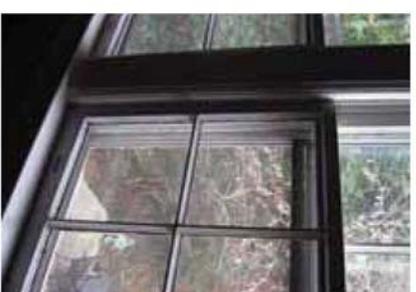
**Not Recommended:** [31-32]  
 Ill-fitting exterior aluminum storm windows viewed from both inside and outside are clearly not energy efficient.

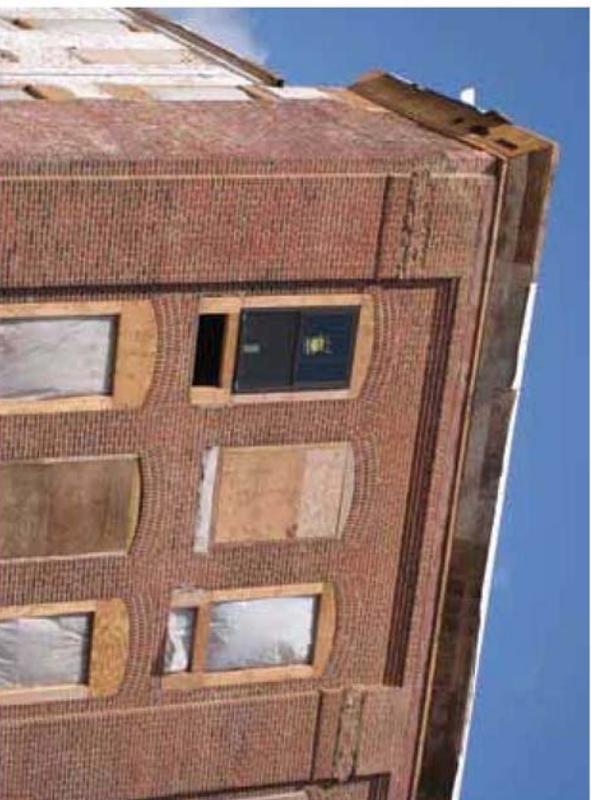
30

**Not Recommended:** [30] Not only have incompatible windows that do not fit the size and shape of the historic window openings been installed, but the original openings have also been shortened to install through-the-wall HVAC units.

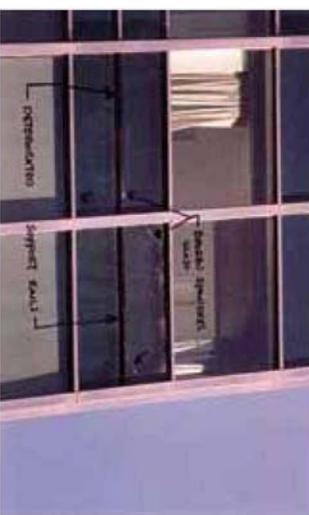
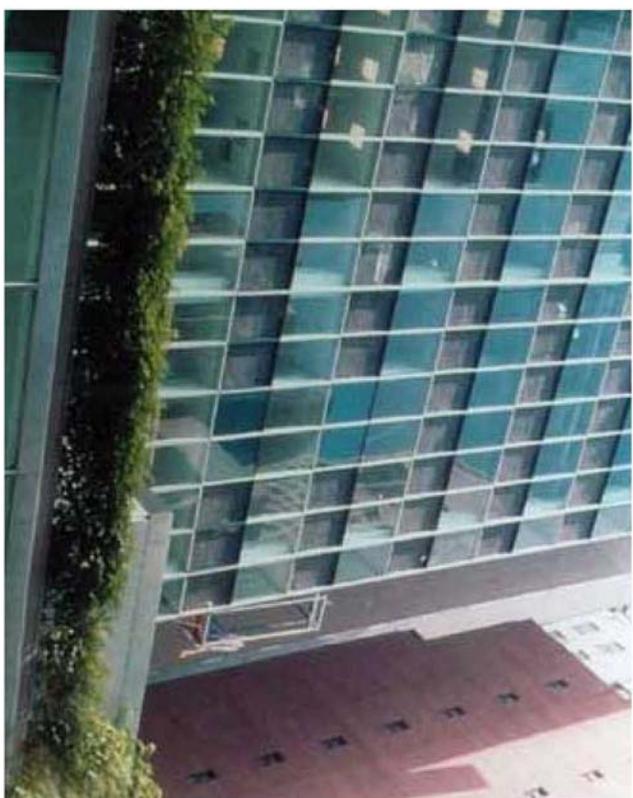
**Recommended:** [39-40] The original windows, which were deteriorated beyond repair, featured a dark tint. They were replaced with a slightly lighter-tinted glazing to improve daylighting in this mid-century modern office building.

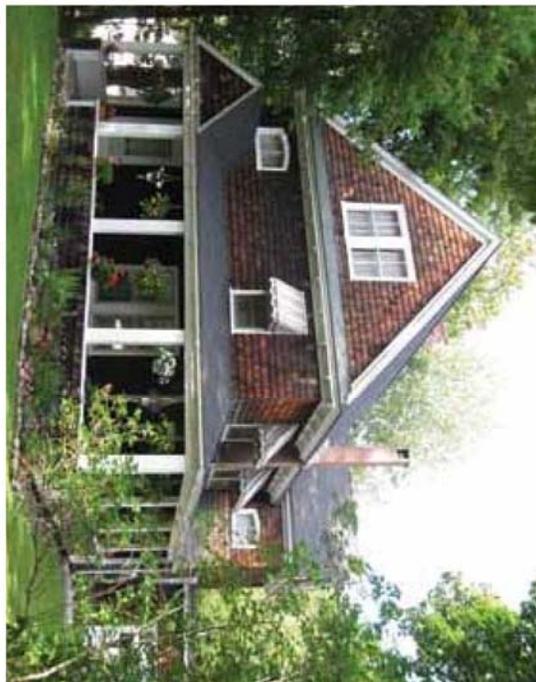
41

**Recommended:** [41] Traditional canvas awnings should be retained when they exist on historic buildings.

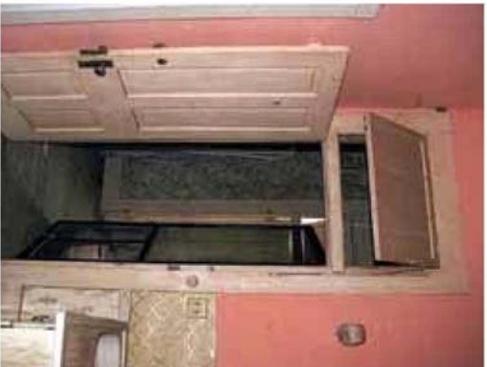
42

**Recommended:** [42] Transoms and screen doors are distinctive and practical features that provided cross ventilation in this historic hotel.

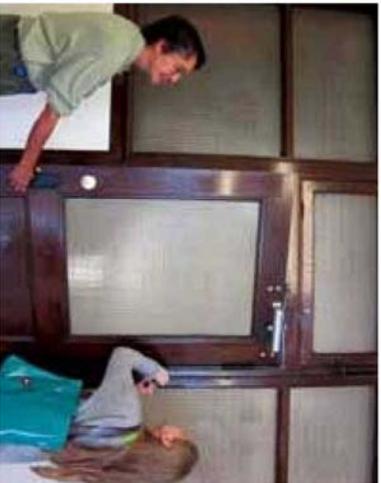
43

**Recommended:** [43] The wall and door glazing ensures that the corridor receives natural daylight and the operable transom helps air to circulate in this historic office building.

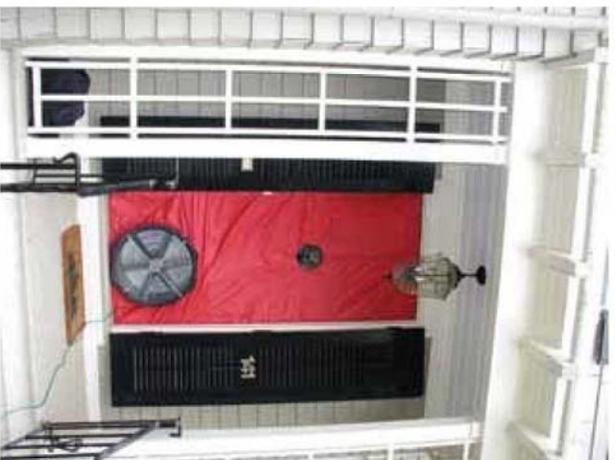
44

**Recommended:** [44-45] A blower door test is a useful tool to help identify air infiltration in a historic building before undertaking weatherization or retrofit treatments.  
 Top Photo: Robert J. Cagnetta, Heritage Restoration, Inc.

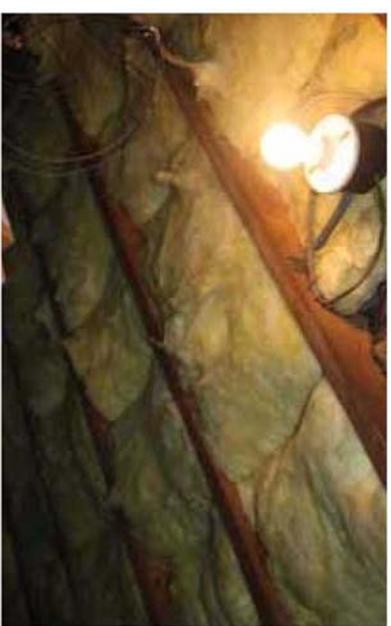
48

**Recommended:** [47-48] Insulation should be installed first in unfinished areas such as attics, crawl spaces and basements of residential buildings.

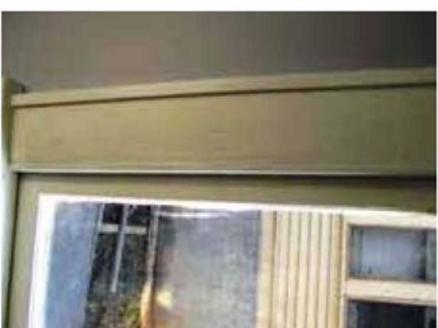
53

**Recommended:** [52-53] The original proportion and relationship of the wall to the windows and trim, which is important in defining the character of these historic interior spaces, has been retained here.

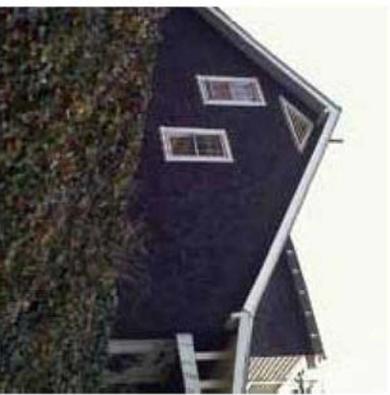
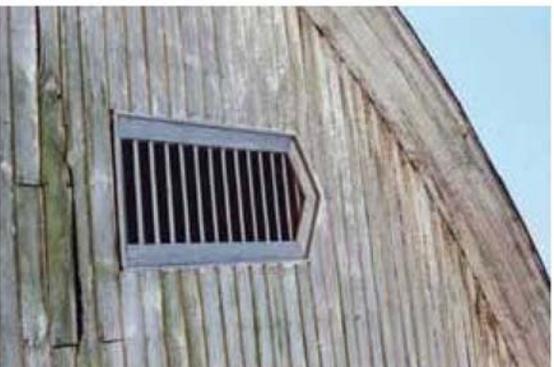
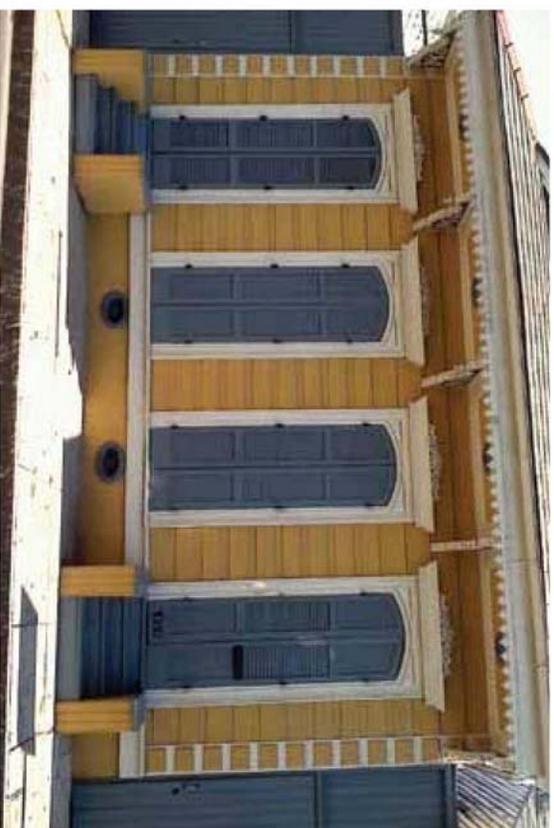
**Recommended:** [55-57]  
Wood vents in the gable ends of a historic house and a barn and cast-iron oval vents in a masonry foundation traditionally helped air circulate.

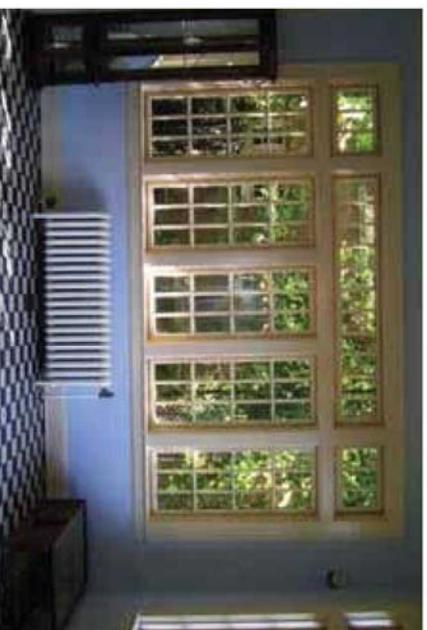
60

**Recommended:** [60] Original radiators that are still functional and efficient were retained in the rehabilitation of this historic house.

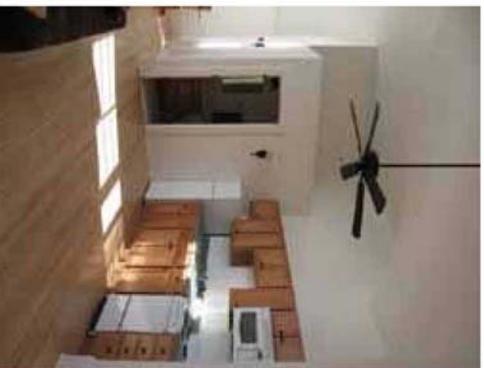
58

**Recommended:** [58] Ceiling fans enhance the efficiency of HVAC systems in historic buildings.

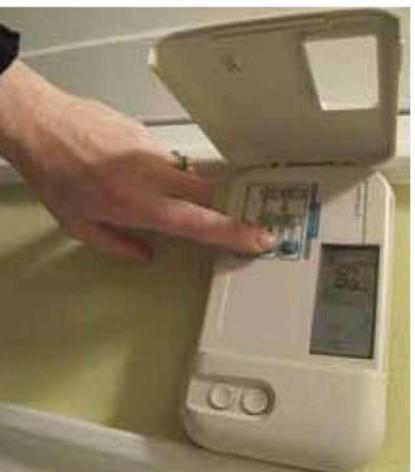
59

**Recommended:** [59] Installing a programmable thermostat can help existing systems to operate more efficiently.

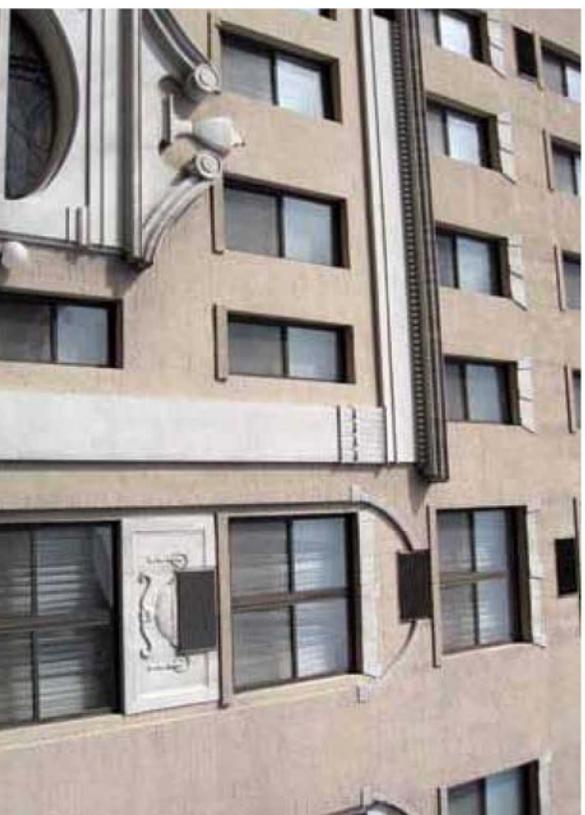
61

**Not Recommended:** [61] The cuts made in the brick and the decorative stone trim to install through-the-wall air conditioners have not only destroyed building material, but have also negatively impacted the character of this historic apartment building.

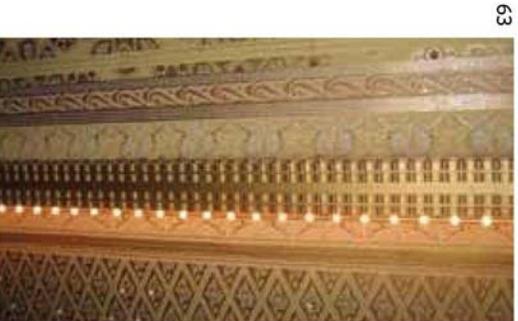
63

**Recommended:** [62-63] Carefully installed new mechanical ductwork is barely visible in the elaborately decorated ceiling of this historic theater.

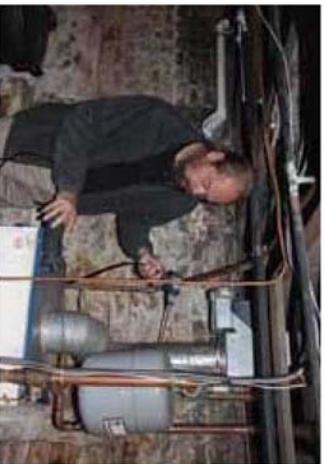
67

**Recommended:**[67] A professional energy auditor analyzes the performance of an existing furnace to ensure it is operating efficiently.

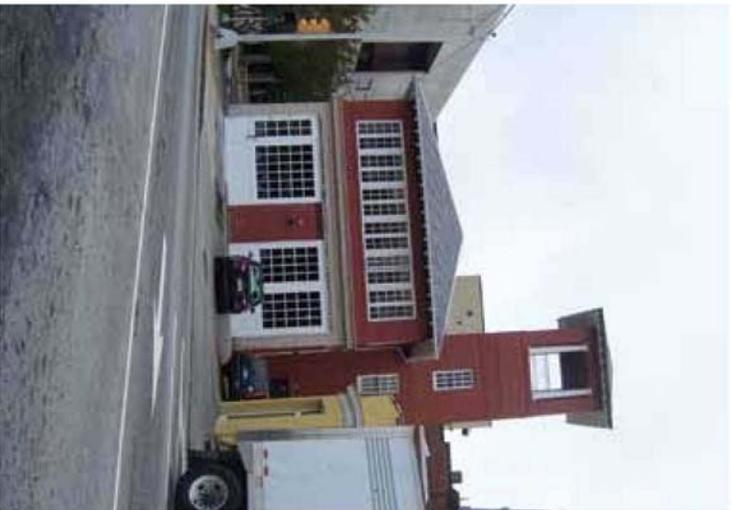
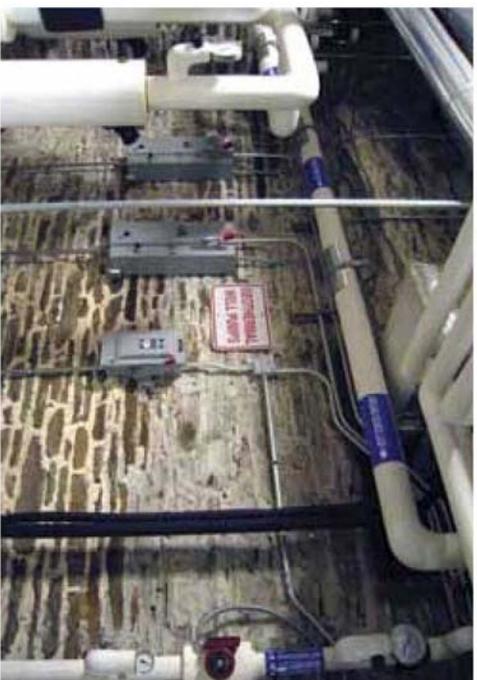
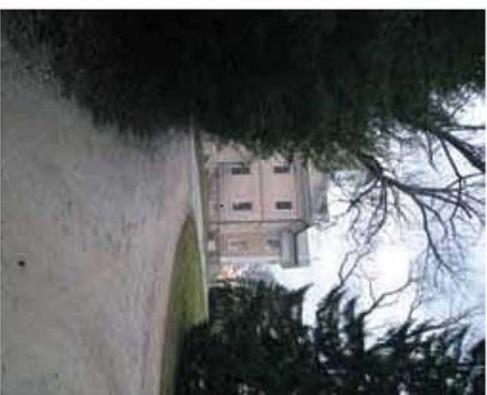
A geothermal system was installed on the property of this historic mansion, but only after an archeological investigation was conducted of the grounds.

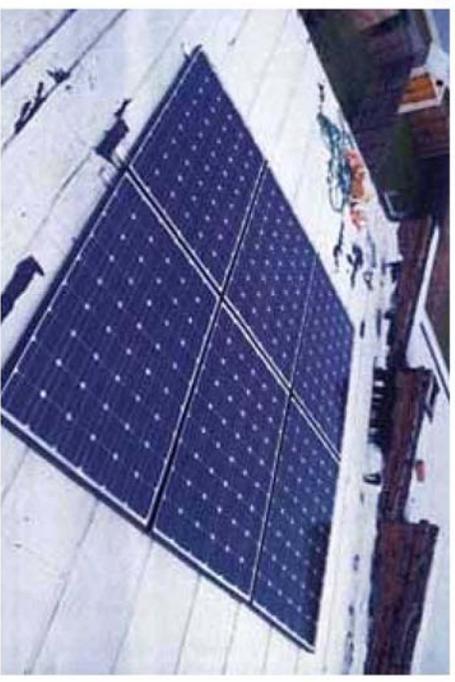
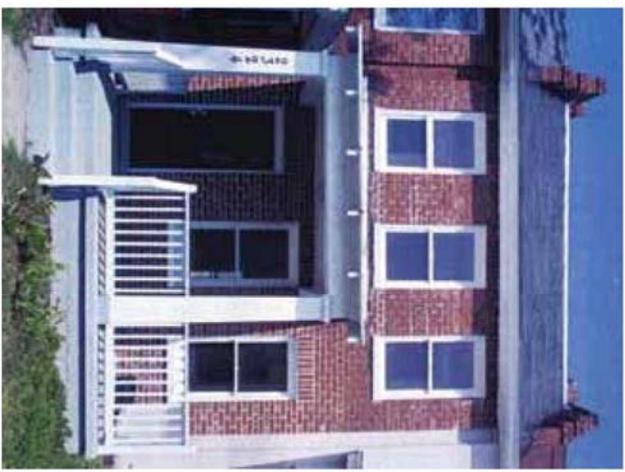
**Recommended:** [72-73] Solar panels were installed appropriately on the rear portion of the roof on this historic row house that are not visible from the primary elevation.

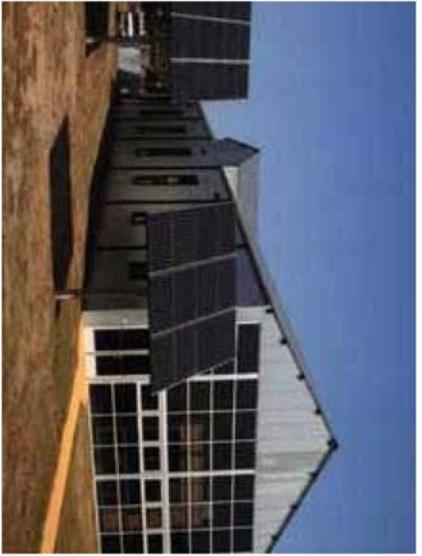
**Recommended:** [74] Free-standing solar panels have been installed here that are visible but appropriately located at the rear of the property and compatible with the character of this industrial site.

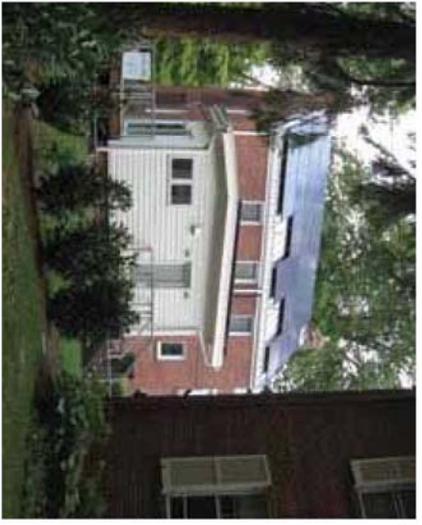
**Not Recommended:** [75] Solar roof panels have been installed at the rear, but because the house is situated on a corner, they are highly visible and negatively impact the character of the historic property.

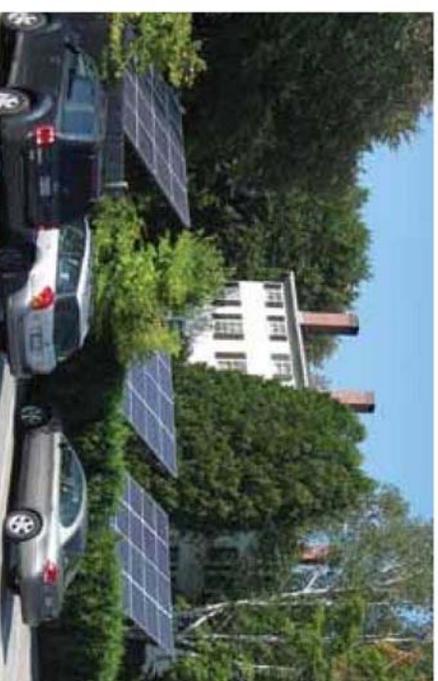
79

**Not Recommended:** [79] Although installing solar panels behind a rear parking lot might be a suitable location in many cases, here the panels negatively impact the historic property on which they are located.

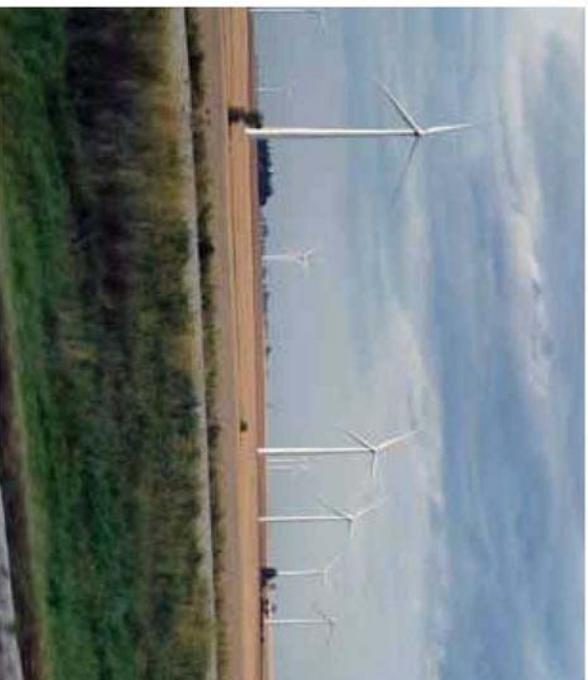
80

**Recommended:** [80] It is often best to install wind-powered equipment in off-site, rural locations to avoid negatively impacting a historic building and its site.

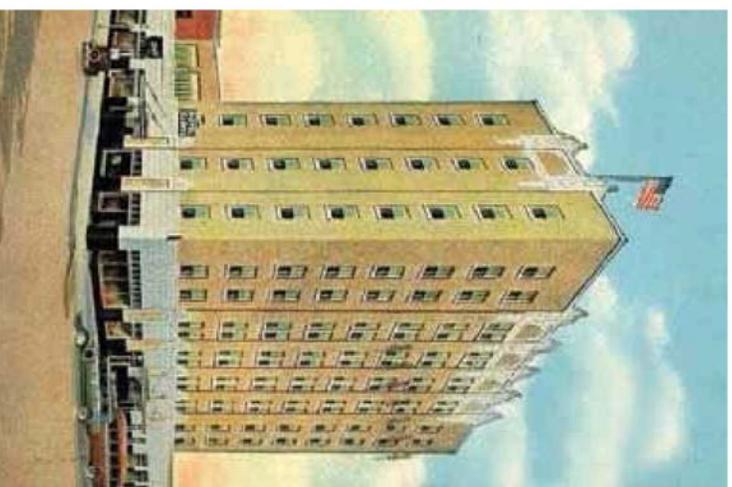
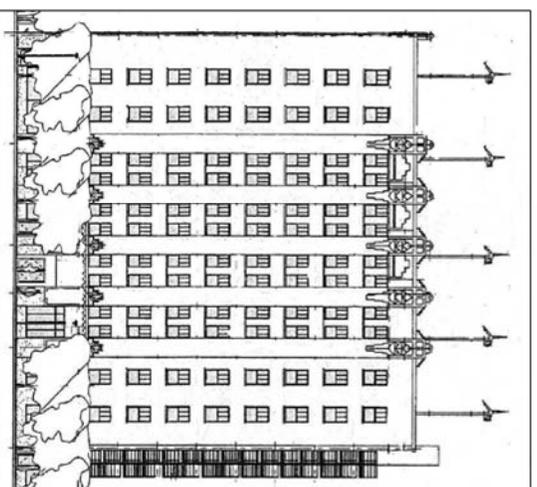
**Not Recommended:**  
[83-84] This historic hotel is a prominent and highly visible local landmark, and the wind turbines proposed to be added on the roof would negatively impact its historic character.

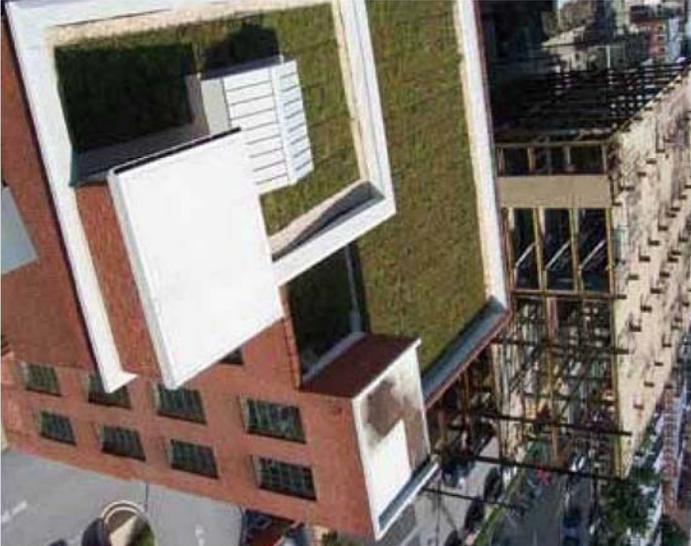
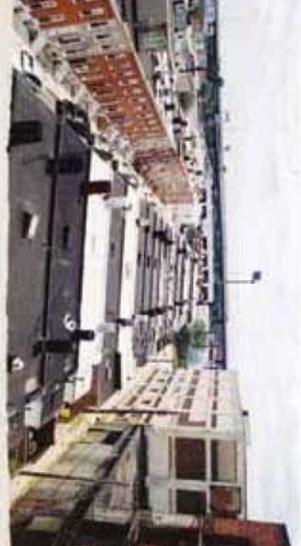
**Recommended:** [85-86] A cool or green roof is best installed on a flat roof where it cannot be seen from the public right of way and will not negatively impact the character of the historic building.

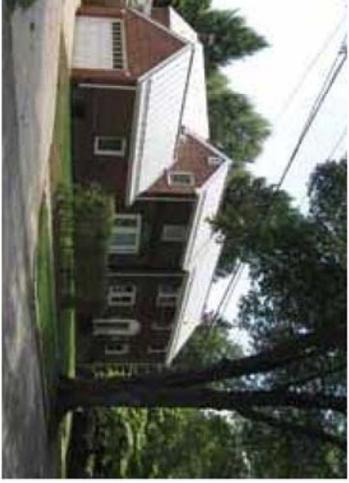
**Not Recommended:** [88] This new, cool white metal roof is not an appropriate material or color for this historic mid-20th century house.

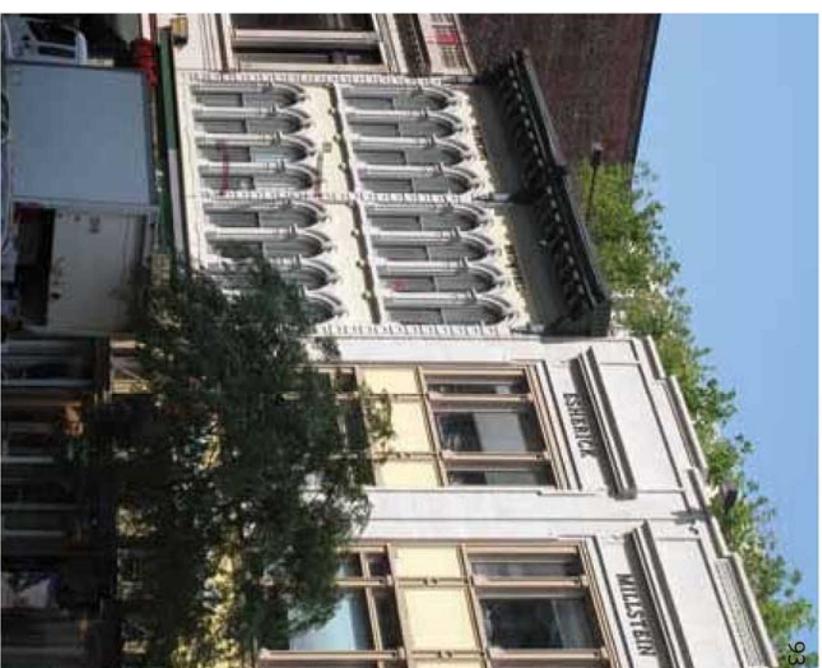
93

**Not Recommended:** [93] The vegetation on these green roofs has grown too tall and negatively impacts the character of these historic commercial buildings.

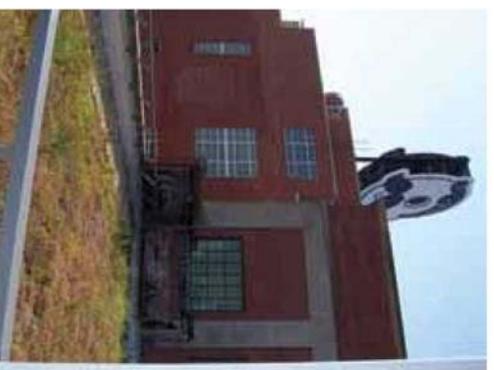
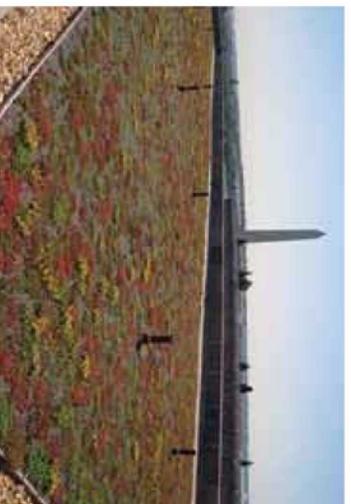
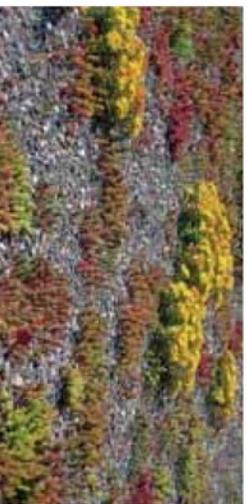
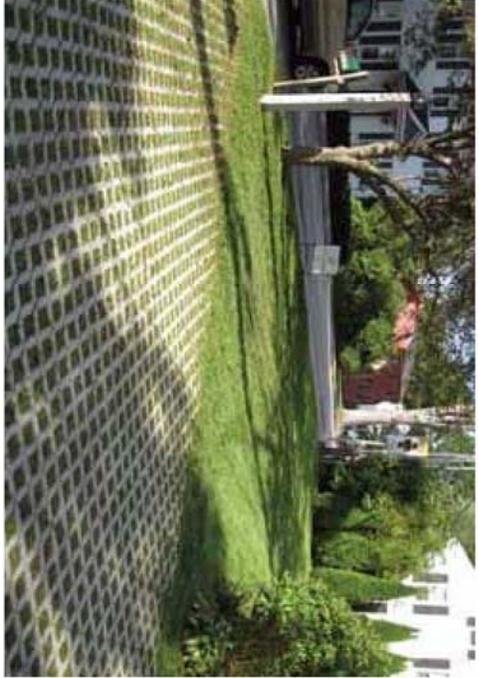
**Recommended:** [89-92] Low-scale and sustainable native plants are appropriate for these roof gardens on historic buildings.

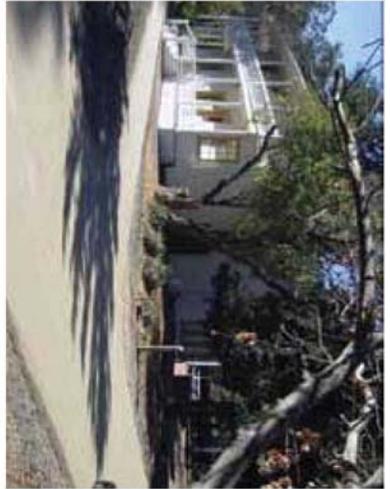
95

**Recommended:** [94-95] Permeable pavers were used at this historic residential property for a driveway and parking (above) and a hard-packed, construction aggregate provides environmentally-friendly paths for visitors at this historic site (below).

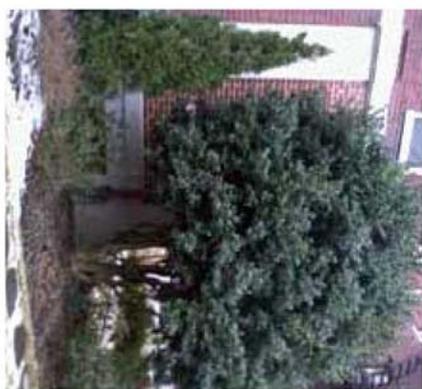
97

**Not Recommended:** [97] This tree, which was planted too close to the building, has caused the masonry wall to retain moisture that damaged the mortar and required that the brick be repointed in this area.

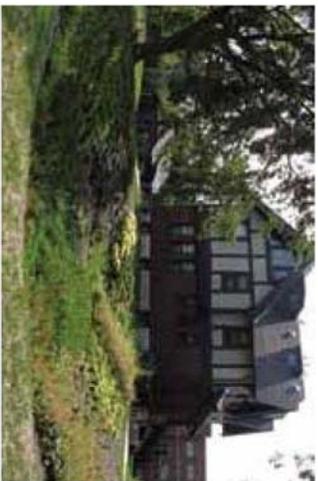
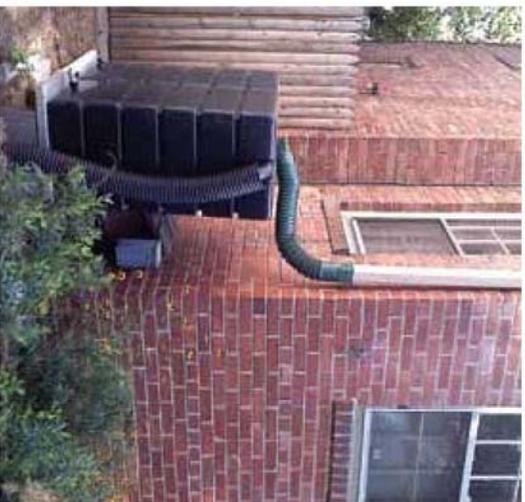
**Recommended:** [98-100] Rain gardens and rain-water collection tanks are features that may be added to a historic property to improve storm-water management and increase on-site water use.

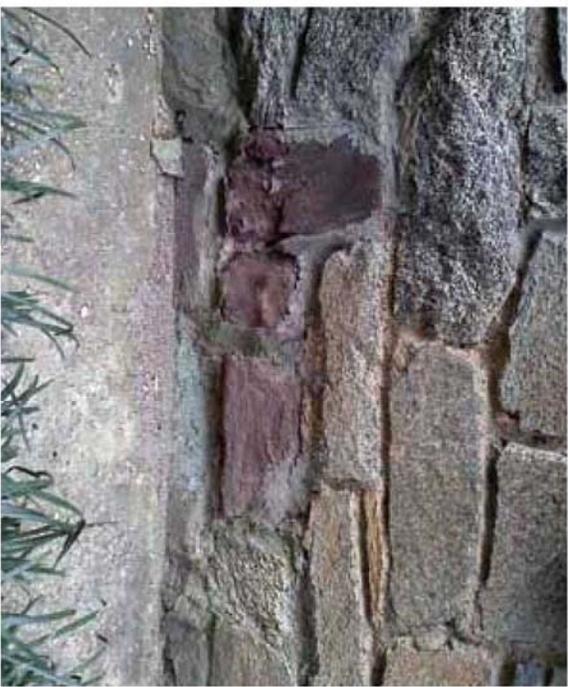
101

**Not Recommended:** [101] Splash back from the impermeable concrete paving next to the foundation is damaging these stones.

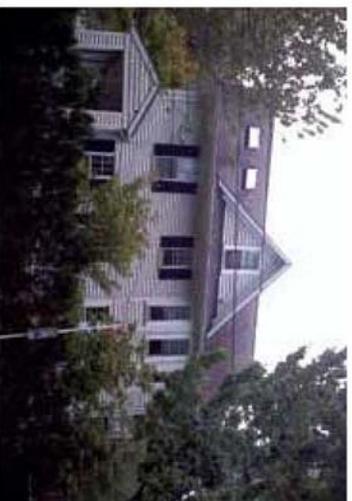
104

**Not Recommended:** [104-106]  
Skylights added on a primary roof elevation negatively impact the character of these historic houses.

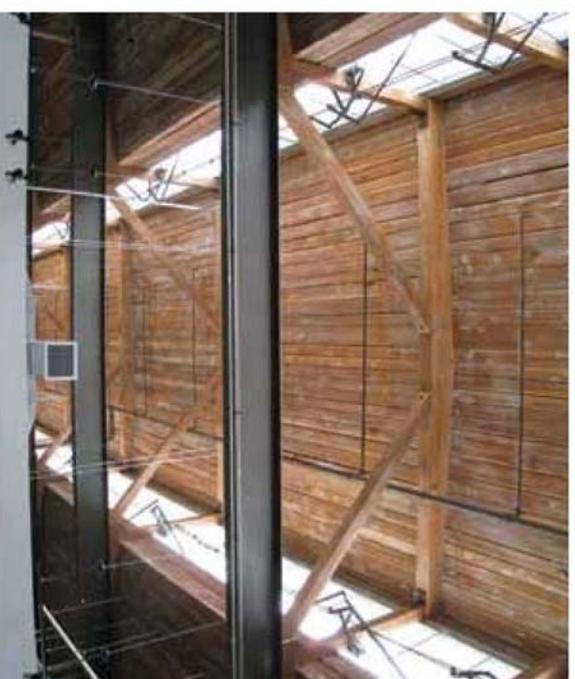
110

**Recommended:** [110] A clerestory window lights the interior corridor of this historic mill building.

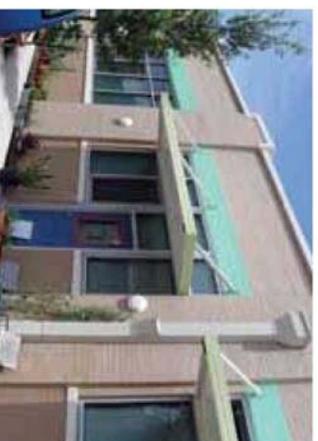
107

**Recommended:** [107] Traditional canopies compatible with the industrial character of this former factory building were installed when it was converted for residential use.
